Report No. 0162-01TN-62-19

RESULTS AND ANALYSES  
OF AEROJET-GENERAL UTILITY VAN  
CERTIFICATION PROGRAM

AFBSD Technical Note BSD-TDR-62-329

**AEROJET-GENERAL CORPORATION**

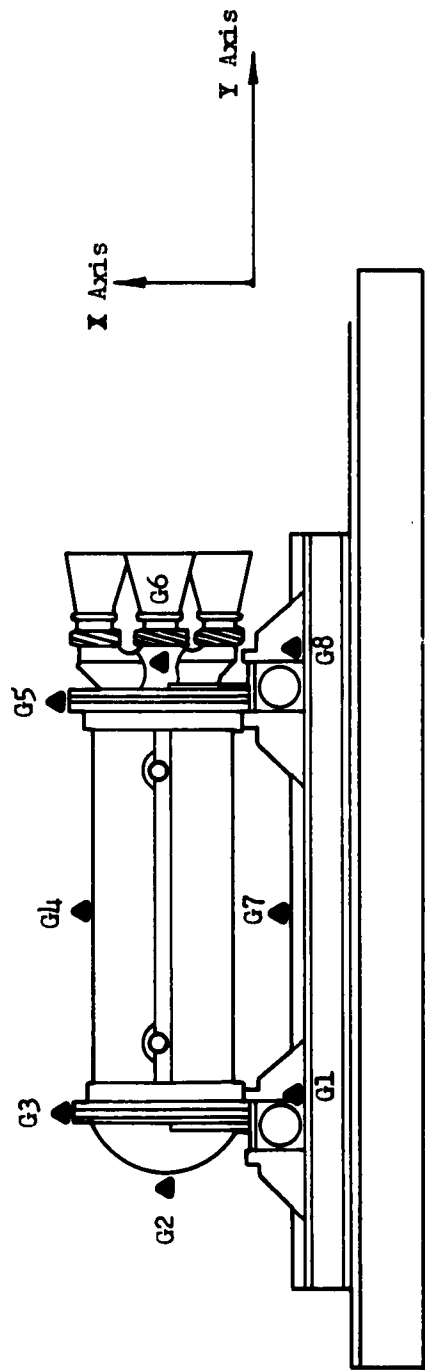
Accelerometer	Range	Location	Recording
G1X	±3G	Forward Tie down left side	Oscillograph
G2X	±3G	Forward Closure	
G2Z	±2G	Forward Closure	
G3X	±3G	Forward Restraint Ring (top)	
G4X	±3G	Top Center of Engine	
G5X	±3G	Aft Restraint Ring (top)	
G6X	±3G	Aft Closure Center	
G6Y	±2G	Aft Closure Center	
G7X	±3G	Truck bed Center of Engine	Oscillograph
G7Y	±2G	Truck bed Center of Engine	
G7Z	±2G	Truck bed Center of Engine	
G8X	±3G	Aft Tie Down Right Side	Oscillograph

Location of Response Accelerometers

Instrumentation of van, harness, and motor is shown in Figures 1 and 2. Figure 1 shows the 12 accelerometer locations used for van-and-harness combinations a through d.

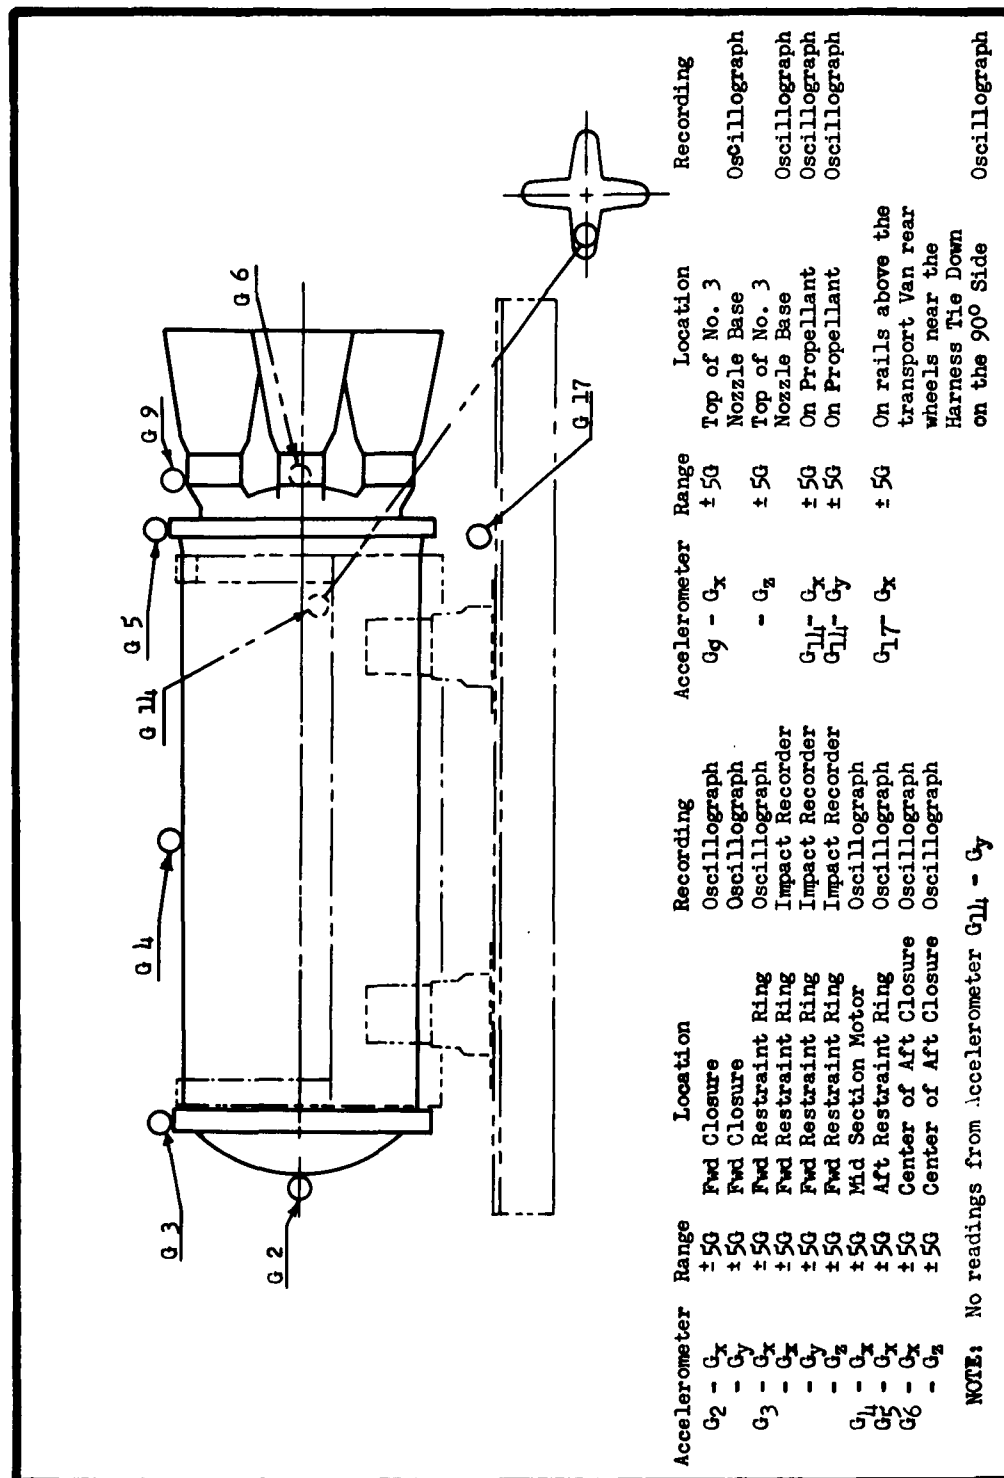
Accelerometer Locations for Oscillograph Recordings for Plank-Strip Test of  
TBC Van and Harness With Motor 44ME-4

Figure 2 shows the instrumentation locations as modified for the plank-strip-course test of the TBC van and harness. The BGS 107 alarm set and the oscillographic accelerometers were compared in conjunction with this test. Data obtained from six accelerometer locations are shown in Table 1.

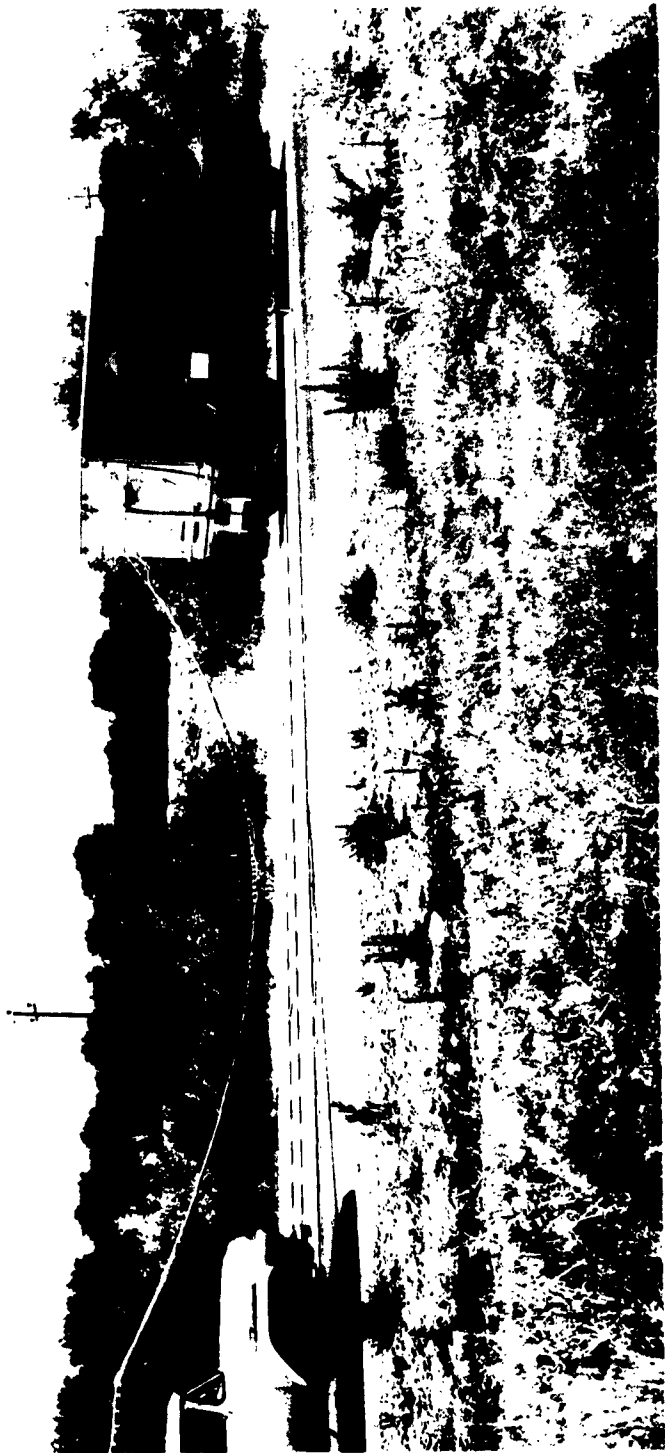
Van-to-Truck Cable Connection

Figure 3 shows the shock-isolation mounting of the recording equipment in the aft end of the van for van-harness combinations a through d. For the test of combination e and the additional high-level-acceleration tests described in section III. C. 5, the data-recording equipment was placed in a shock-isolation mounting on the bed of an accompanying truck. Cables from the van to the truck connected the accelerometers to the recording equipment. The truck was driven over a smooth road that paralleled the plank-strip course. Figure 4 shows the van-to-truck cable connection.

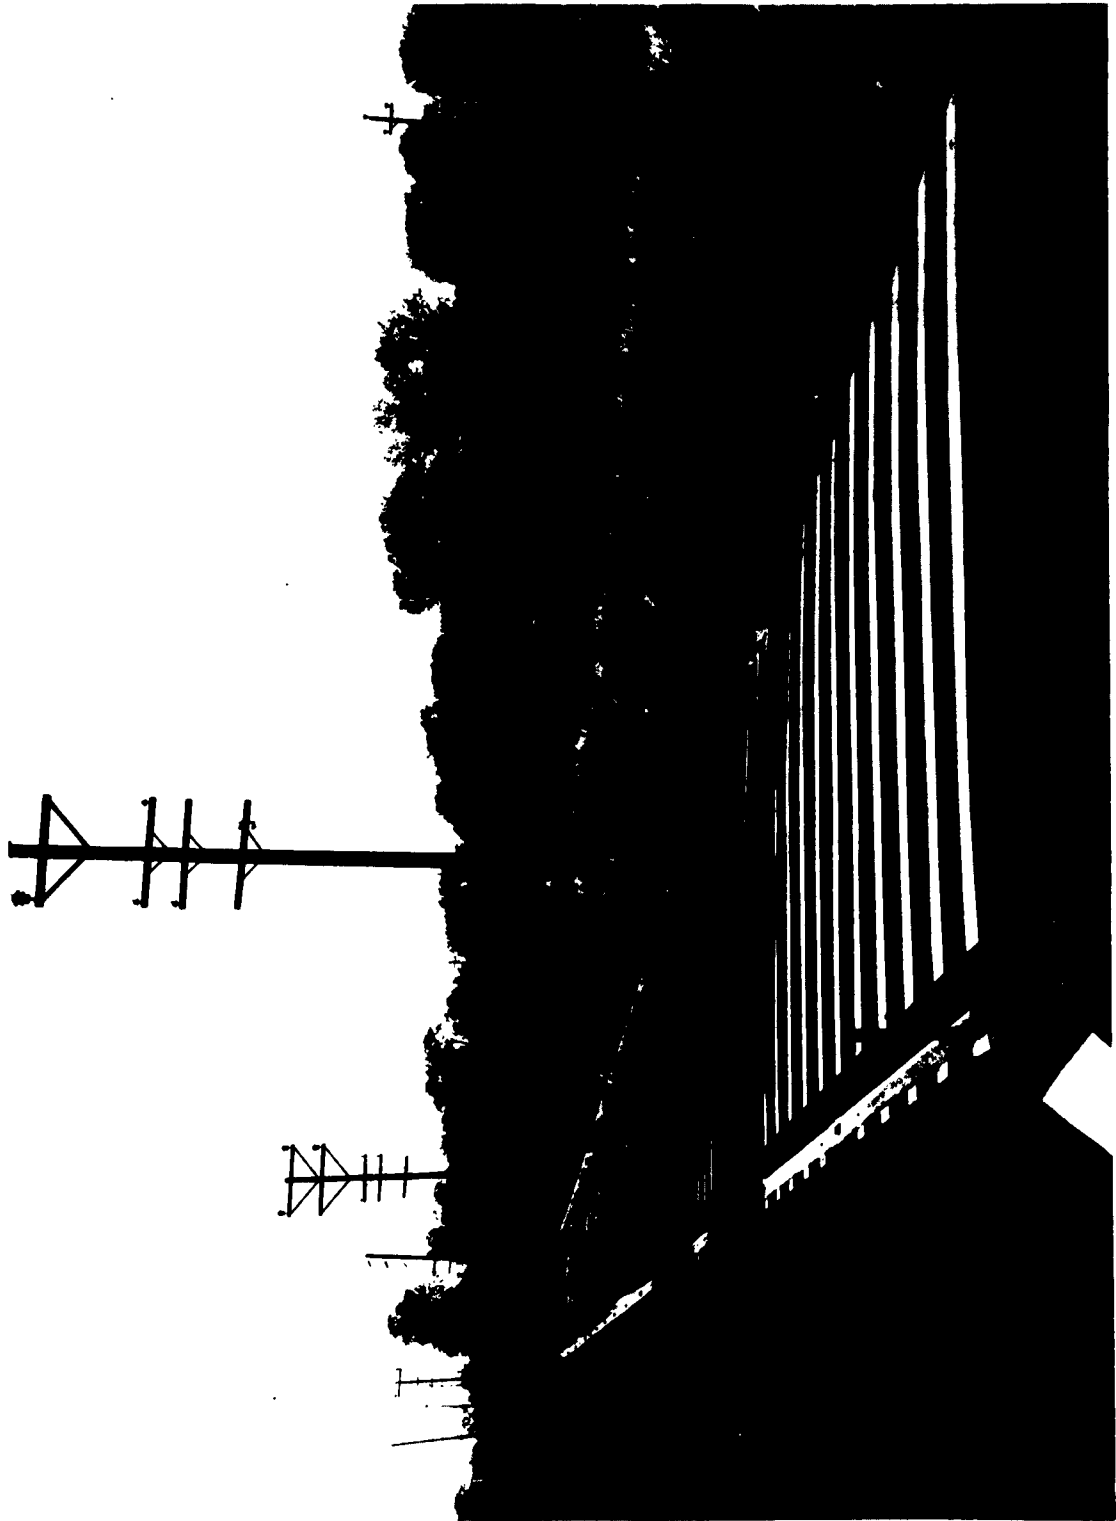
Plank-Strip Course Installation (0.25-in. -High Plank Strips, 200-ft Course Length)

The 0.25-in. -high plank-strip course was laid with plywood boards 8 in. wide and 0.25 in. thick. A 200-ft length of the course was used for tests of van-harness combinations a through d. A 100-ft length of the course was used to test the TBC van and TBC operational harness. Figure 5 shows the 200-ft section of the 0.25-in. -high plank-strip course, indicating the type of construction and installation used for all Aerojet board courses.

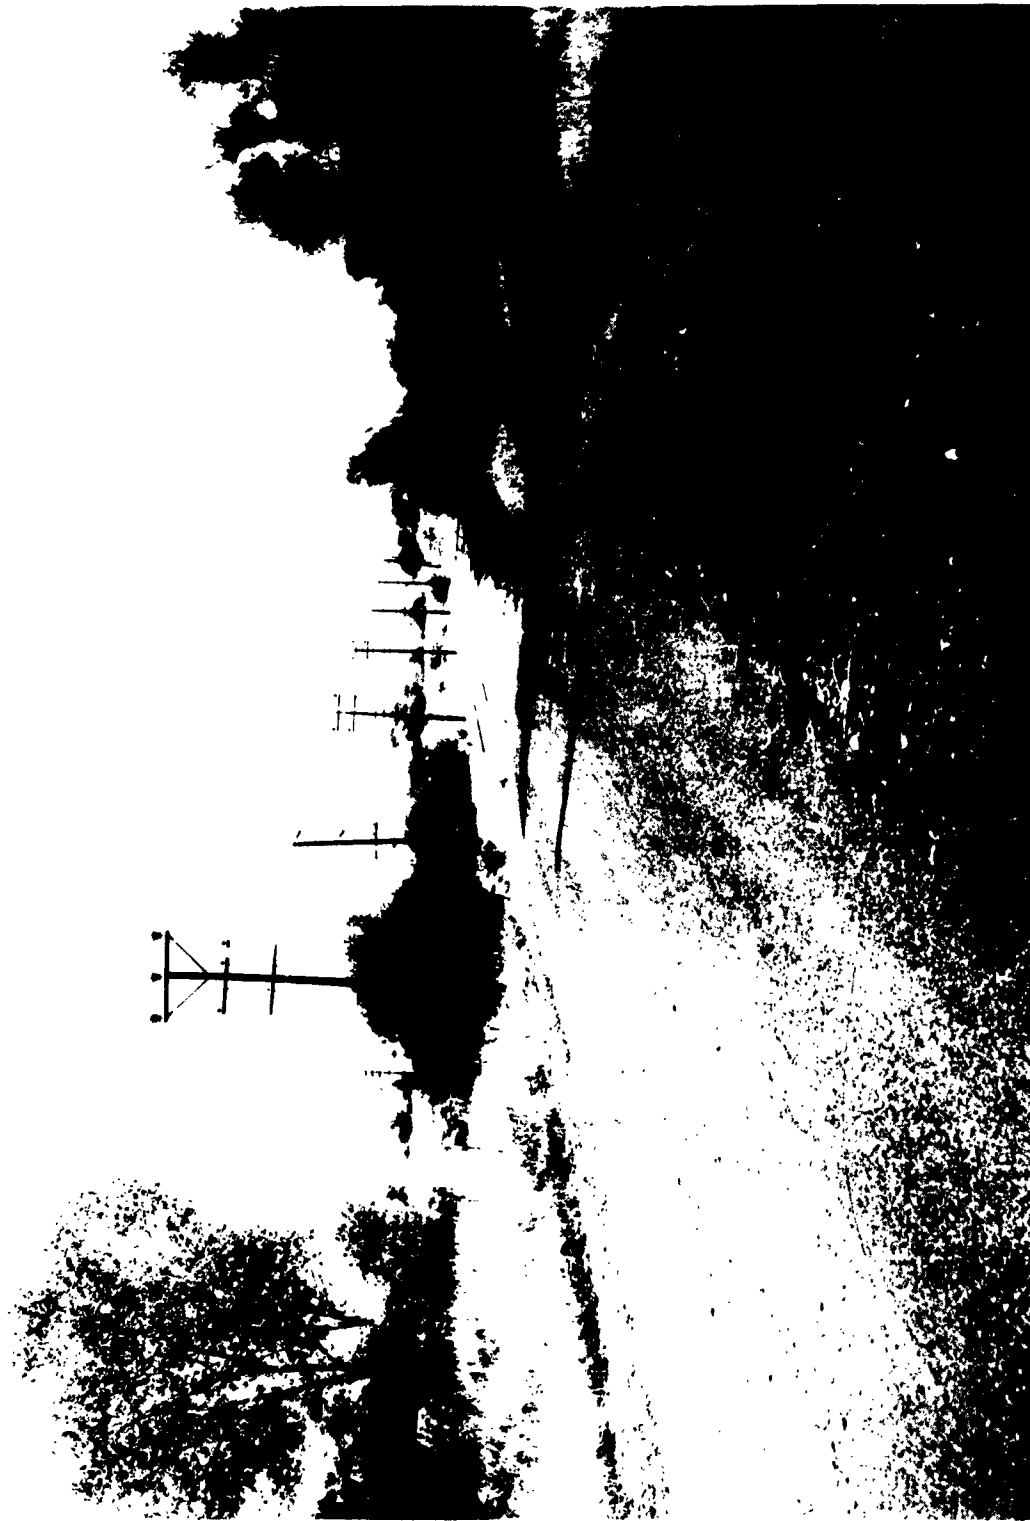
Plank-Strip-Course Test Site at Aerojet-General, Sacramento

The 0.50-in. -high plank-strip course was laid with boards 8 in. wide and 0.50 in. thick. Figure 6 shows the course.

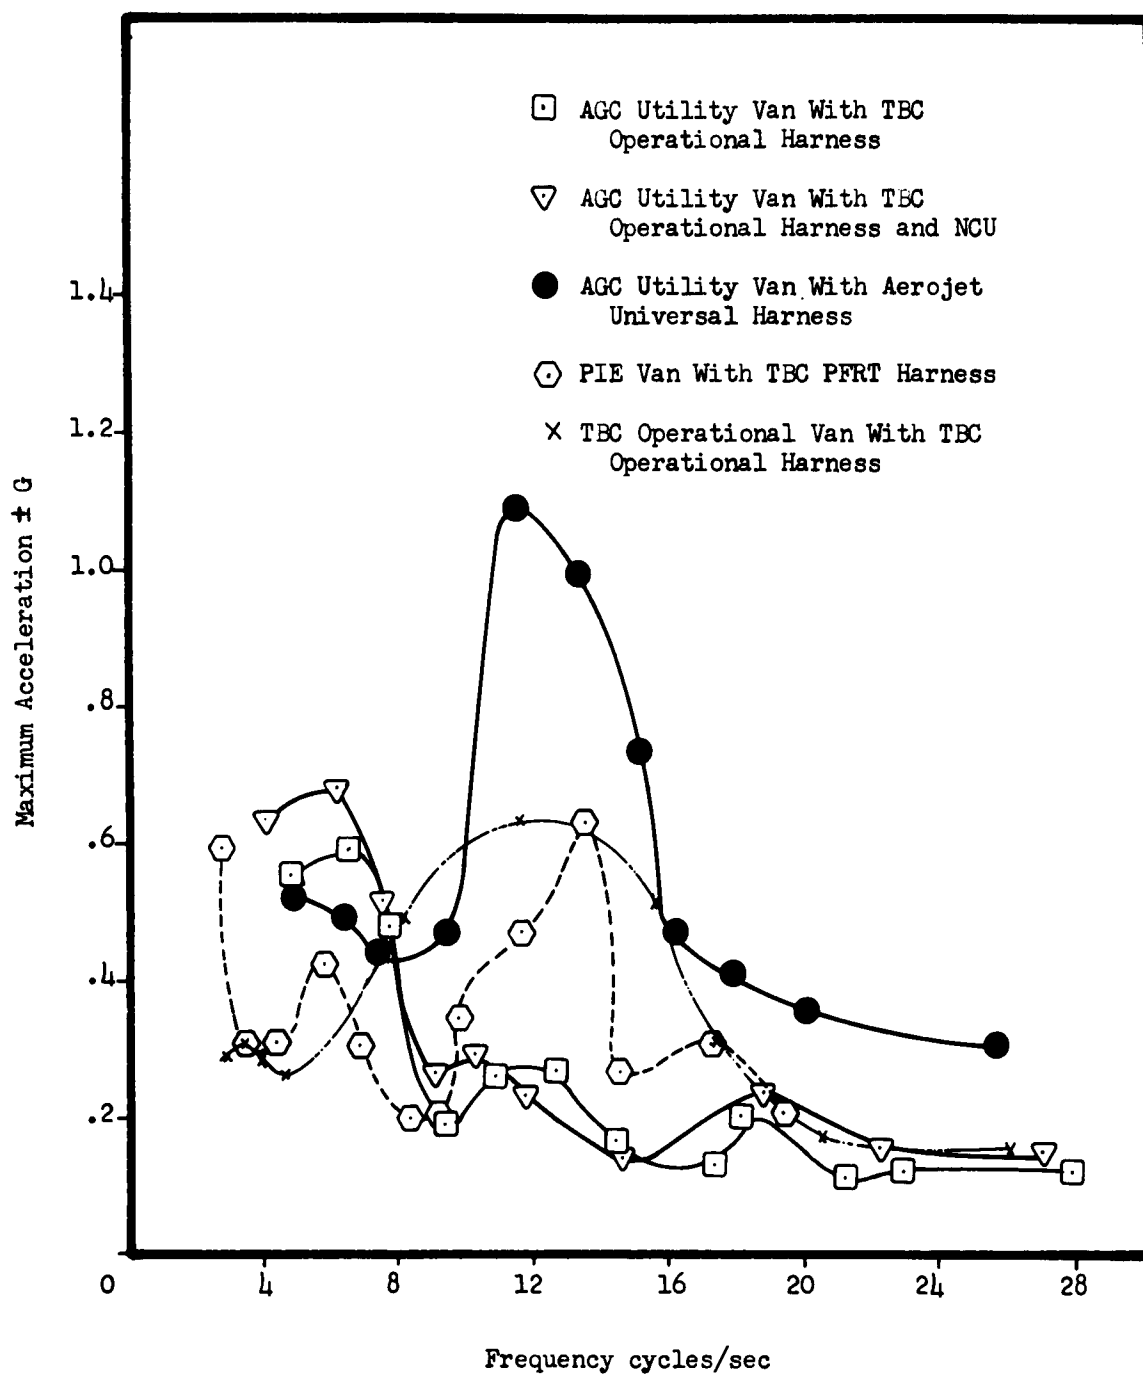
Figure 8

Comparison of Maximum Accelerations at Location G2X for Five Van-Harness Combinations (0.25-in. -High Plank Strips)

The maximum response (in the vertical direction) measured at the forward closure of the motor with accelerometer G2X occurred during the plank-strip-course tests of the Aerojet Utility van-Aerojet harness combination. Maximum acceleration levels of 1.09 g (over the 0.25-in. -high planks) and 1.95 g (over the 0.50-in. -high planks) were recorded at a van speed of 14.8 mph. This corresponds to a vibration frequency of 11.4 cycles/sec.

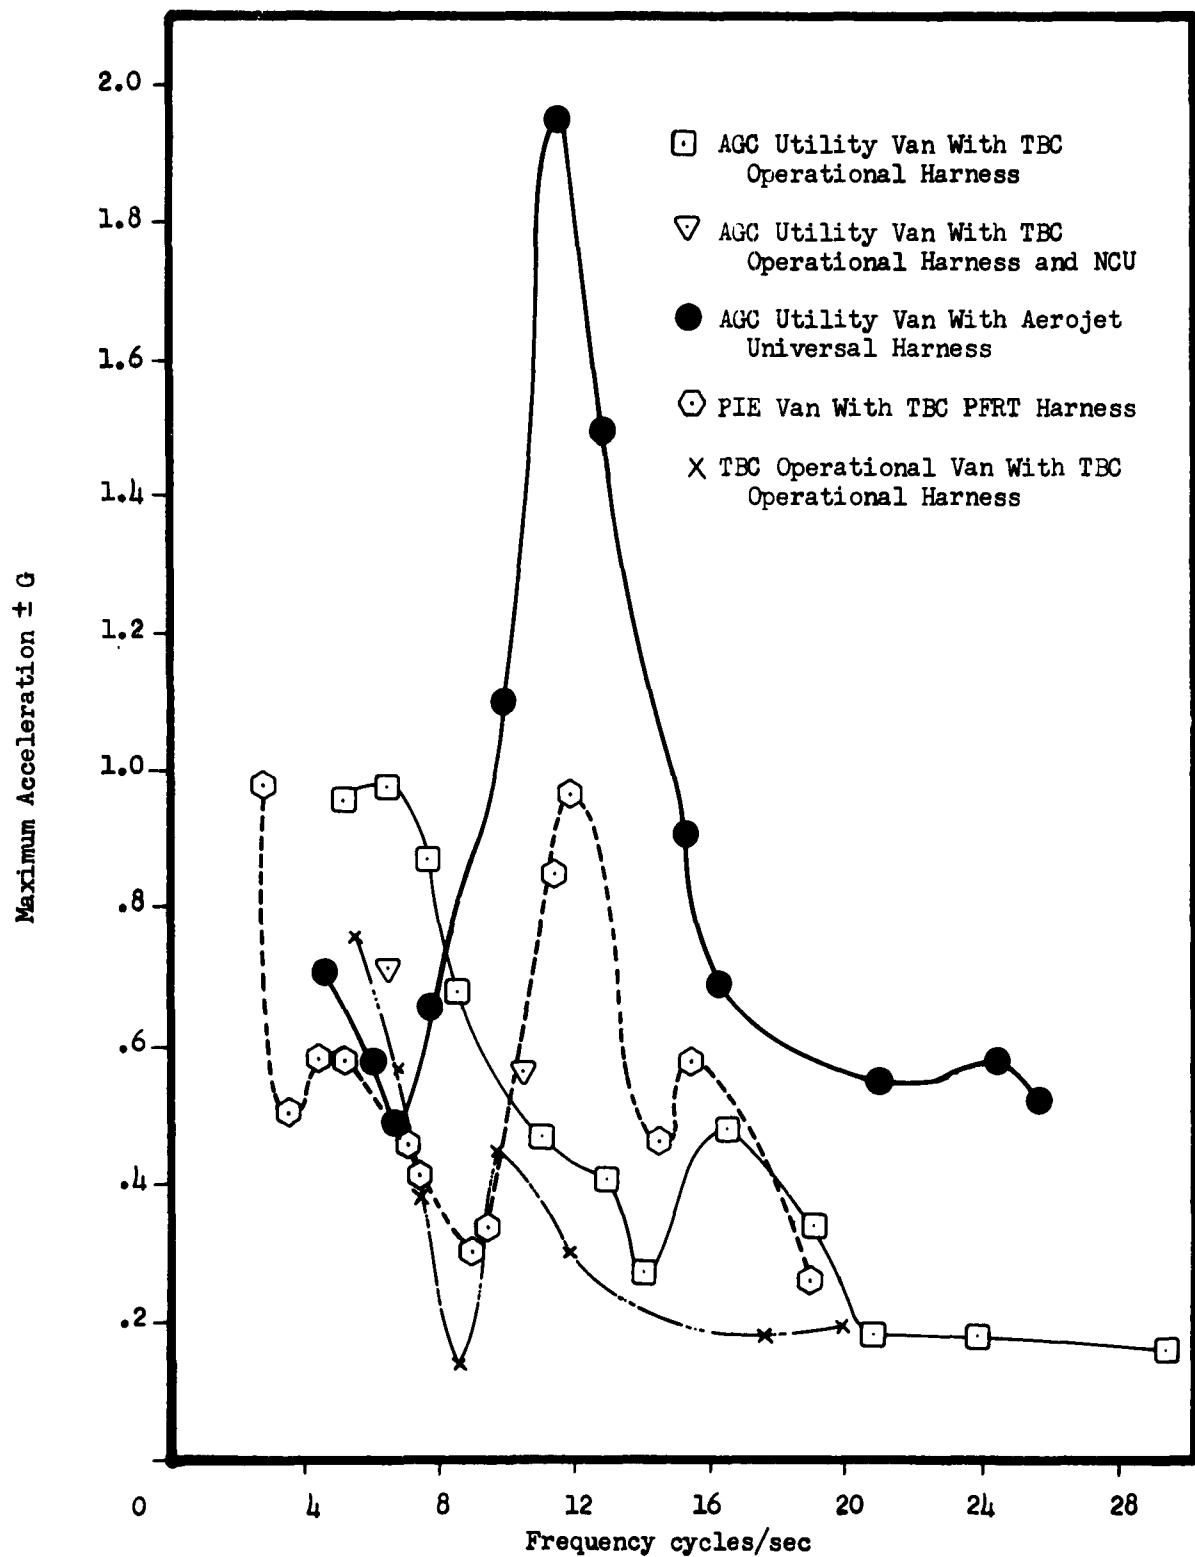
Figure 9

Comparison of Maximum Accelerations at Location G2X for Five Van-Harness Combinations (0.50-in. -High Plank Strips)

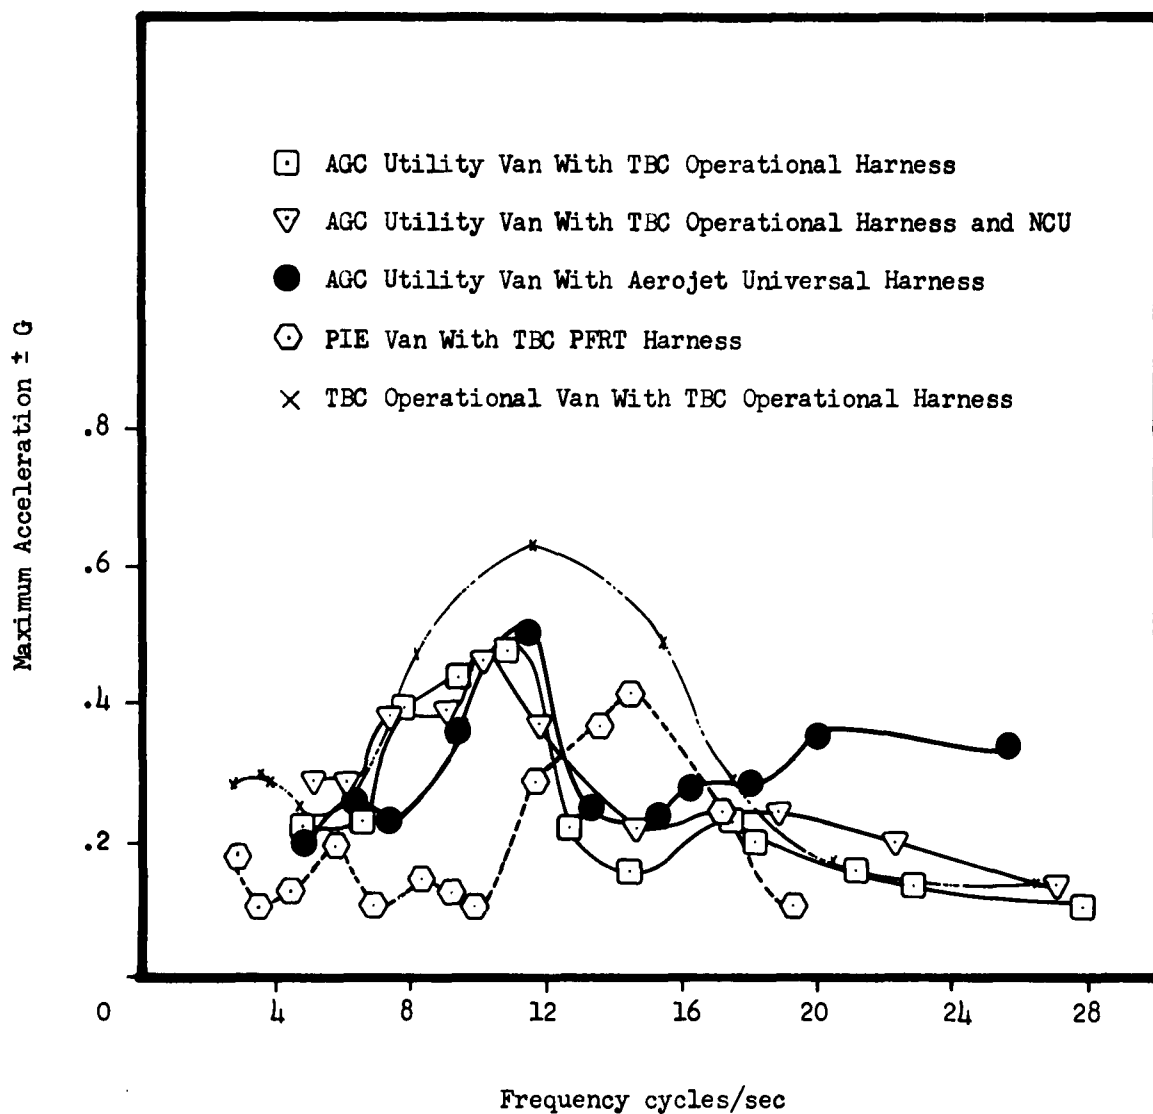
Figure 10

Comparison of Maximum Accelerations at Location G4X for Five Van-Harness Combinations (0.25-in. -High Plank Strips)

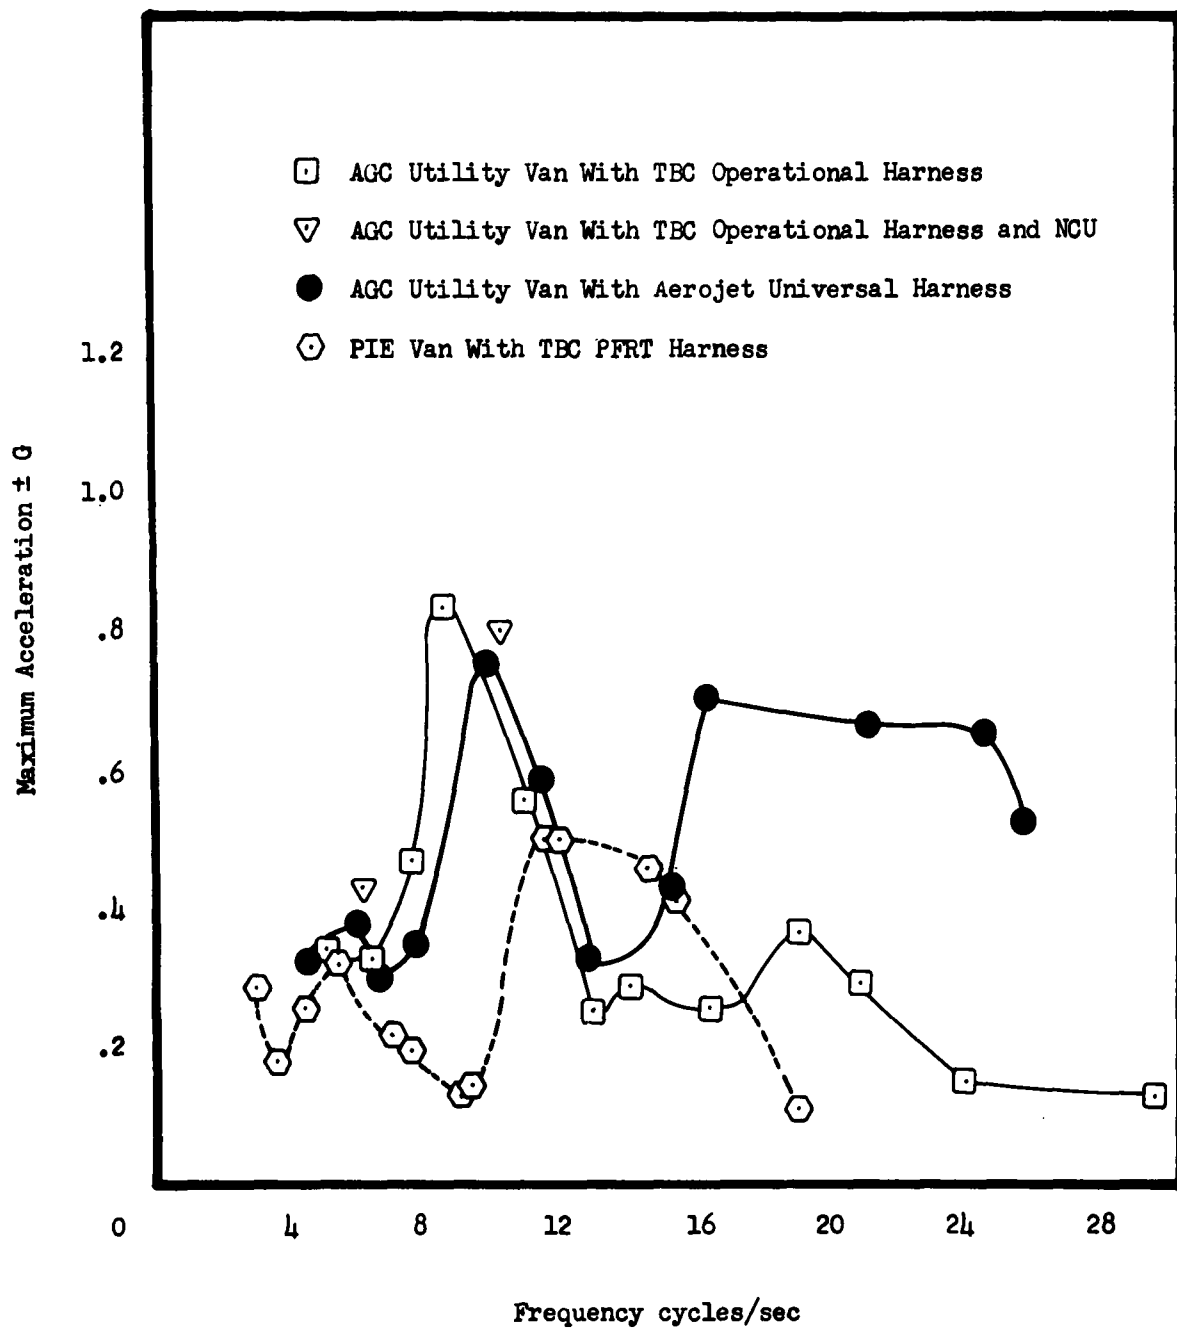
Figure 11

Comparison of Maximum Accelerations at Location G4X for Four Van-Harness Combinations (0.50-in. -High Plank Strips)

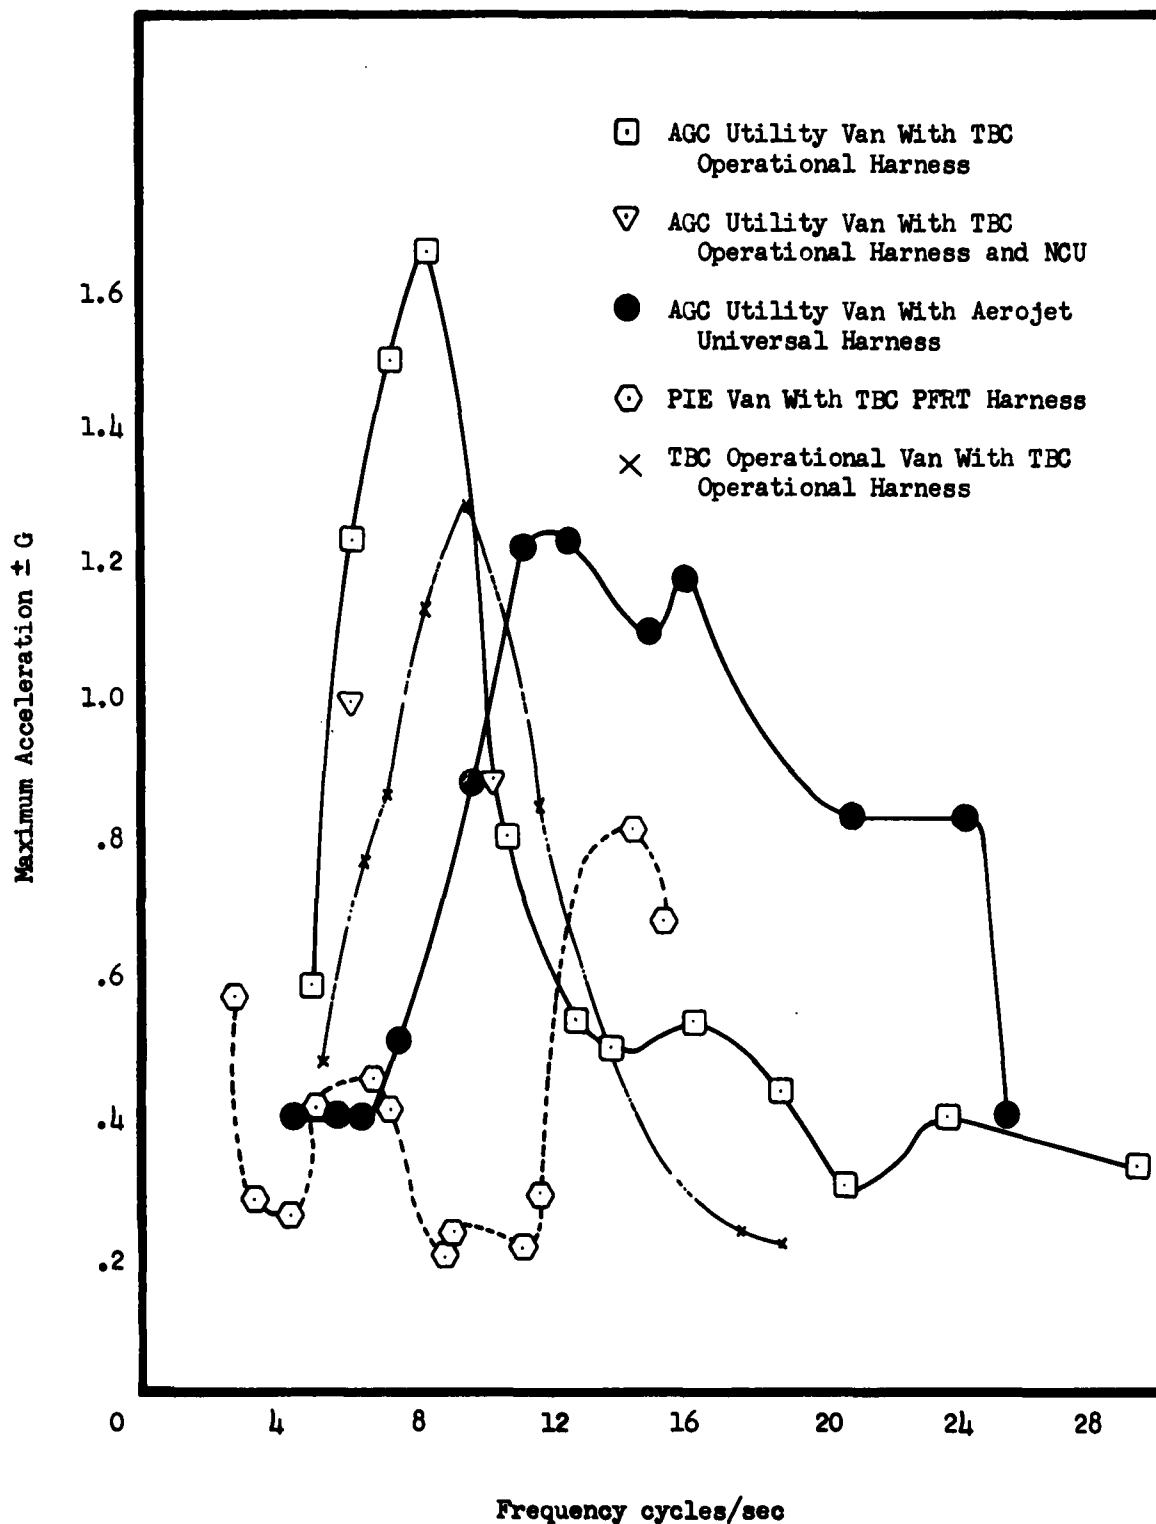
Figure 13

Comparison of Maximum Accelerations at Location G6X for Five Van-Harness Combinations (0.50-in. -High Plank Strips)

A maximum value of 1.29 g was recorded at the G6X accelerometer position on the aft closure of the motor over the 0.50-in. -high plank-strip-course tests of the TBC van with the TBC operational harness. This maximum value of 1.29 g was measured at a nominal van speed of 14 mph, corresponding to a frequency of 9.74 cycles/sec.

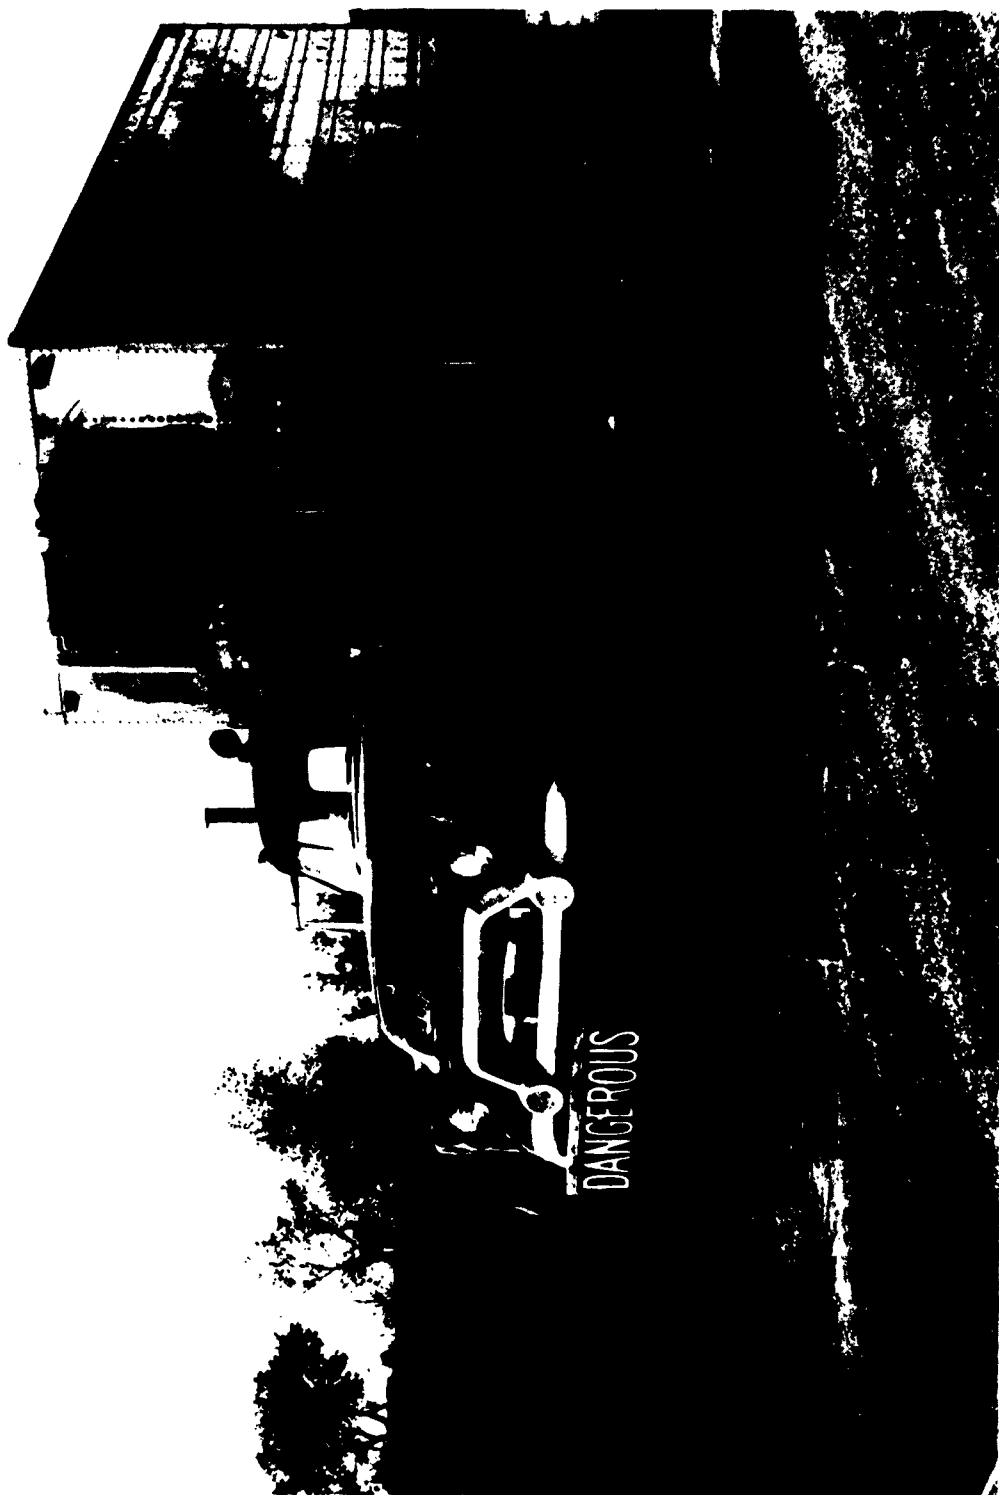
Figure 14

Aerojet Utility Van

Test results obtained from the Van Certification program indicate that the Aerojet Utility van (Figure 14) is acceptable for use as a transport vehicle for second-stage Minuteman motors.
